SMINIM 2018 CALCINA

California Construction and Industrial Materials Association

Quarry Manager Specialty Minerals, Inc. Lucerne Valley, CA

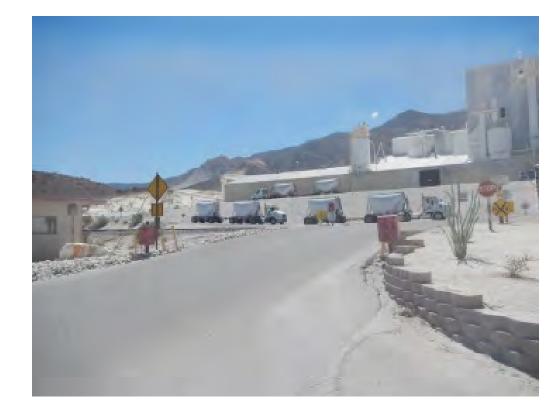
For over fifty-years at our plant, over half of the workforce had to walk along the edge of the busy entrance road from the employee parking

lot to their jobs.

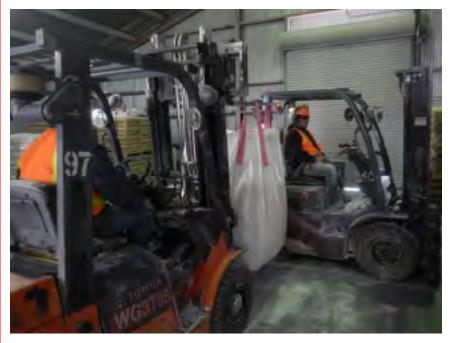
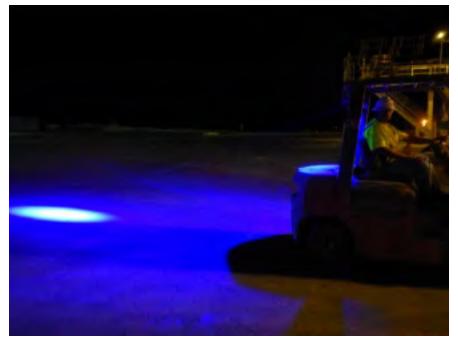
A very serious near-miss occurred when a forklift ran into another forklift which backed out from between two rows of pallets.

A bright, highly visible LED light was installed in place of the white back-up light.

The bright light indicates when a forklift is in reverse.

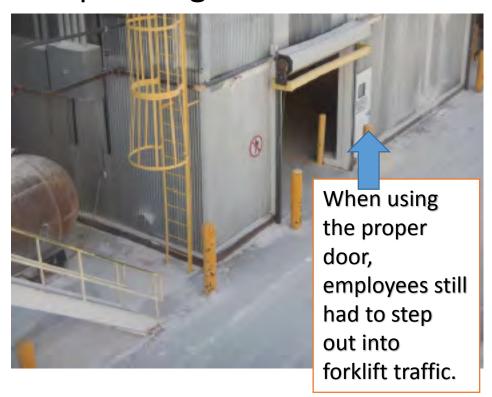
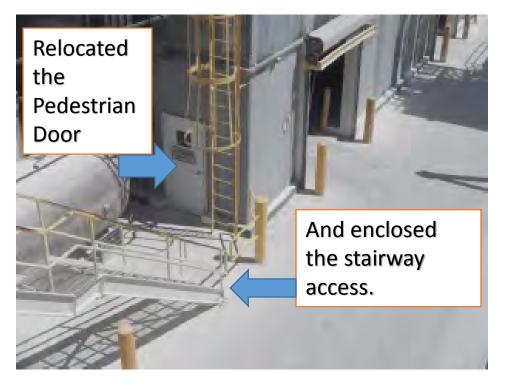
Production workers were required to travel through one of our Mill Buildings to use the stairs to report for work everyday.

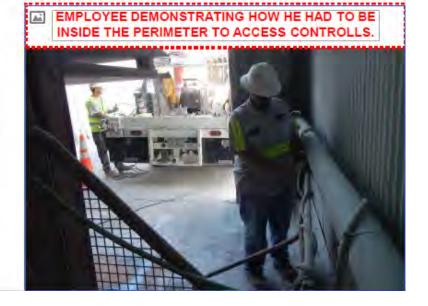
Pallet Flipper Near Miss - Lucerne Valley, CA, - July 21, 2016

Incident Description: A Production temporary worker was operating the packcenter pallet

flipper when he was nearly struck by the device.

- •The pallet flipper structure had been turned 90 degrees so the electrical disconnect mounted on the back side of the flipper frame would be accessible and not against the wall.
- •This placed the start controls that were attached to the protective handrail against the wall.
- •The start controls had to be accessed from inside the structure perimeter which placed workers in close proximity to the pallet flipper.

Start controls were placed against the wall without recognizing the hazard that existed.

- •The start control button was placed on the opposite handrail where it could be safely accessed outside the danger perimeter
- •This is a temporary measure until the electrical disconnect can be moved and the pallet flipper returned to its original position.
